Project Title: Ashgrove Farm, Ardley
Client: Mr J and Mrs R Pickford
BRD Reference: BRD2409-OP4-A
Date Issued: July 2015

**EXPLOSIVE ORDNANCE
DESKTOP STUDY
FOR:**

PROJECT 21056

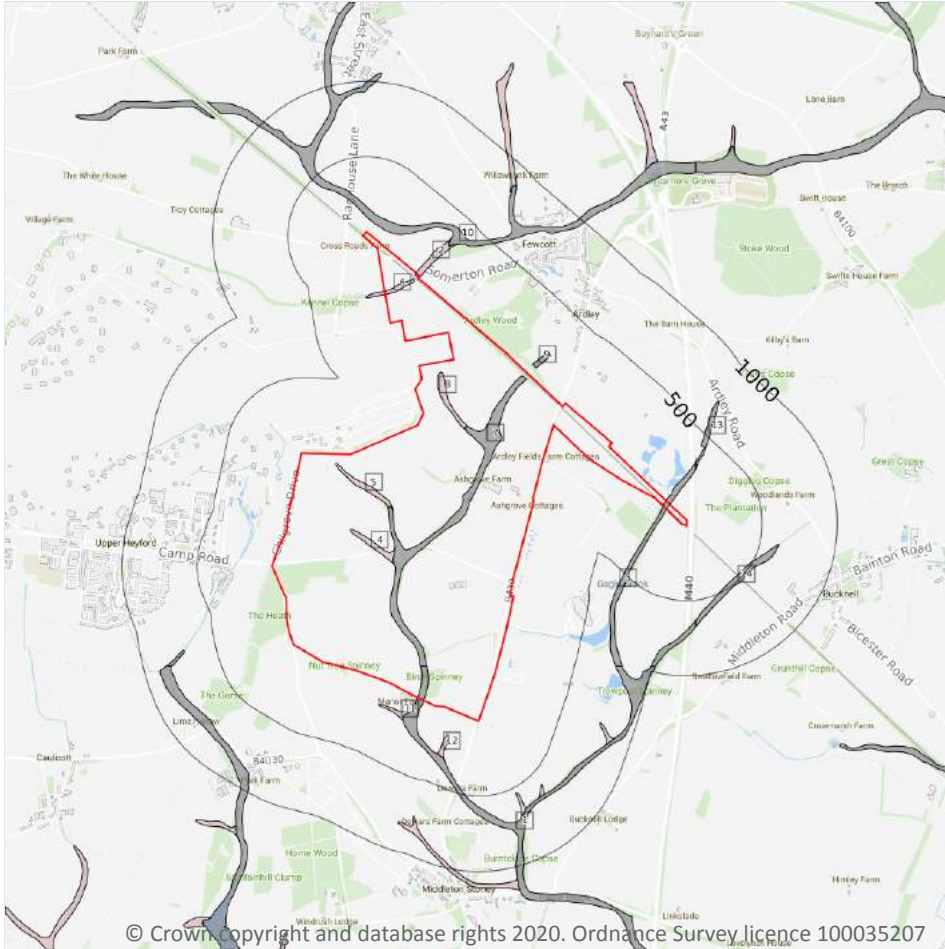
Geology 1:10,000 scale - Superficial

- Site Outline
- Search buffers in metres (m)
- Landlip (10k)
- Superficial geology (10k)
Please see table for more details.

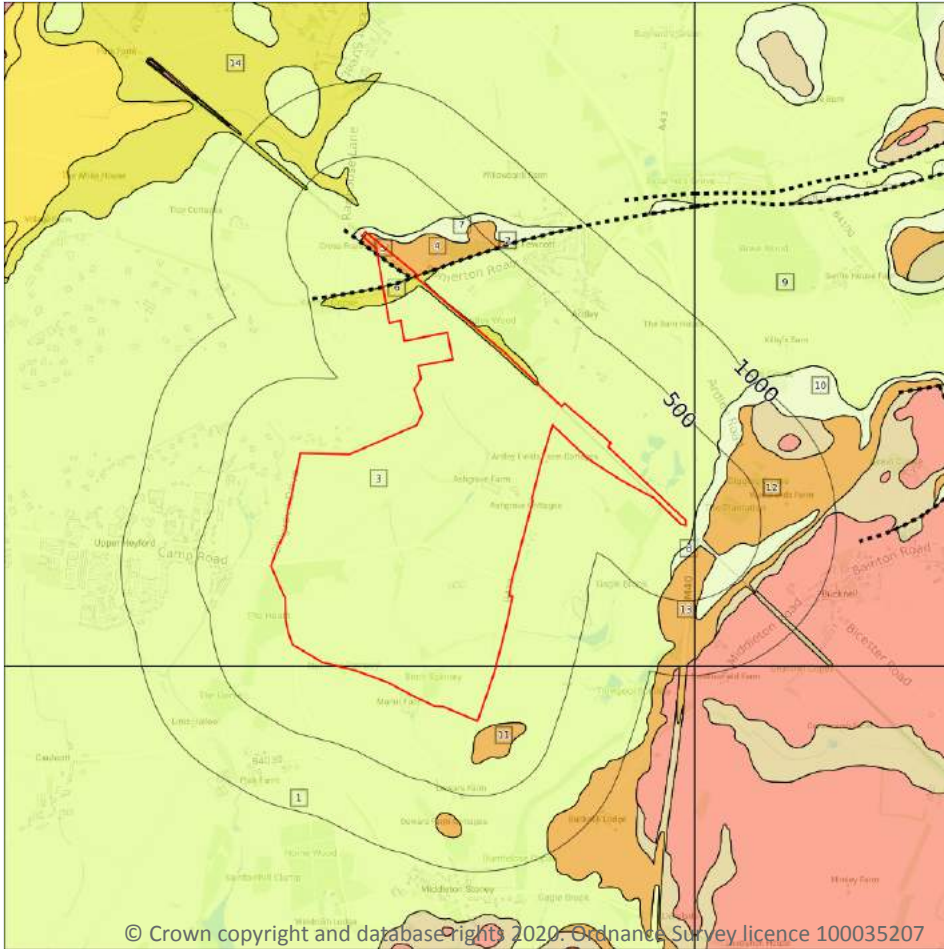
Geology 1:10,000 scale - Bedrock

- Site Outline
- Search buffers in metres (m)
- Bedrock faults and other linear features (10k)
- Bedrock geology (10k)
Please see table for more details.

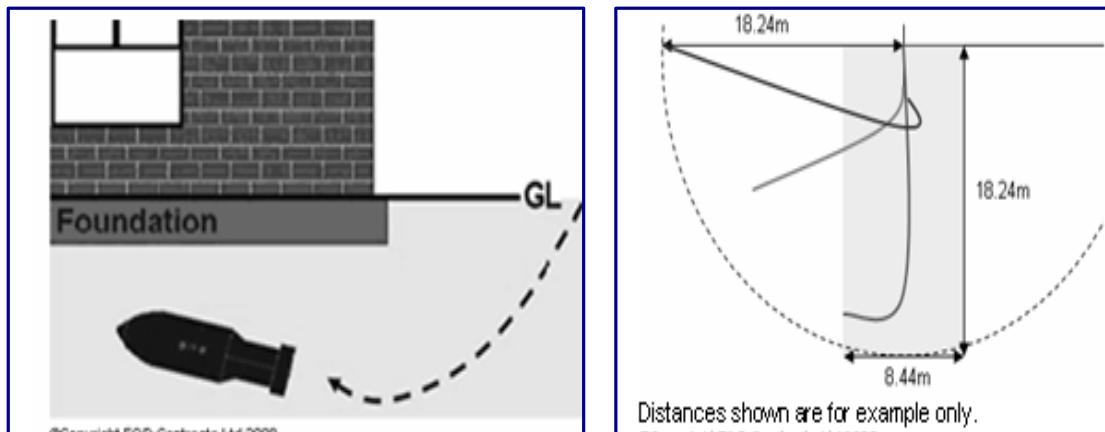
Figure 5.1: Common Sub-Surface Trajectory & **Figure 5.2:** Anomalous Sub-Surface Trajectory

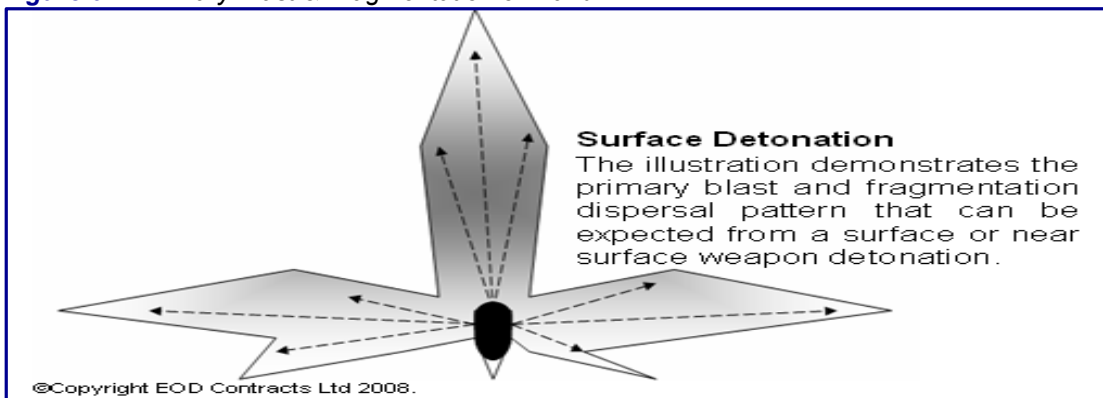
Figure 6.1: Primary Blast & Fragmentation on Land

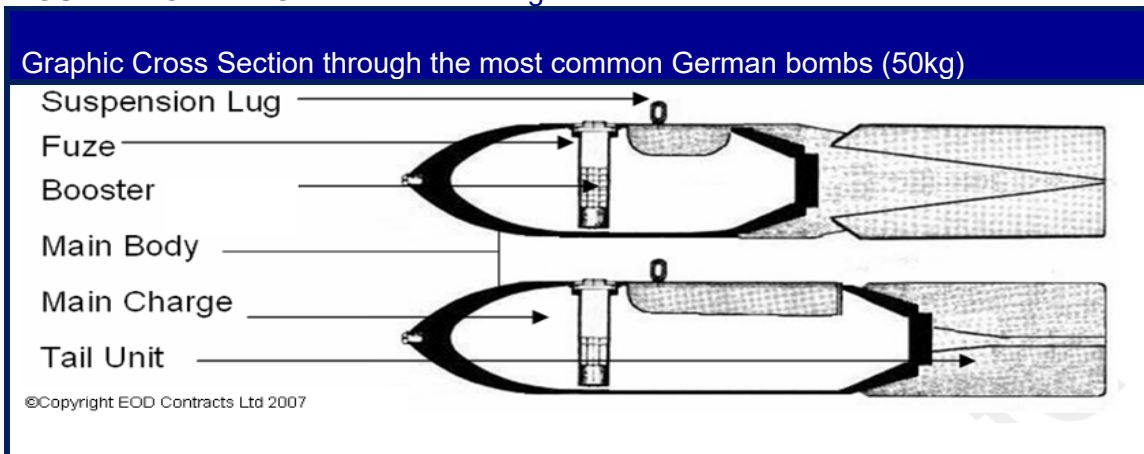
FIGURE 1: Generic German Bomb Design.

NOTE: the diagram shows that there can be a significant difference in the quantity of High Explosive contained within bombs of similar size and shape; the Grade 1 bomb on the bottom having 30% more HE than the Grade 2 shown at the top. This serves to demonstrate the importance of an accurate identification of any item of UXO.

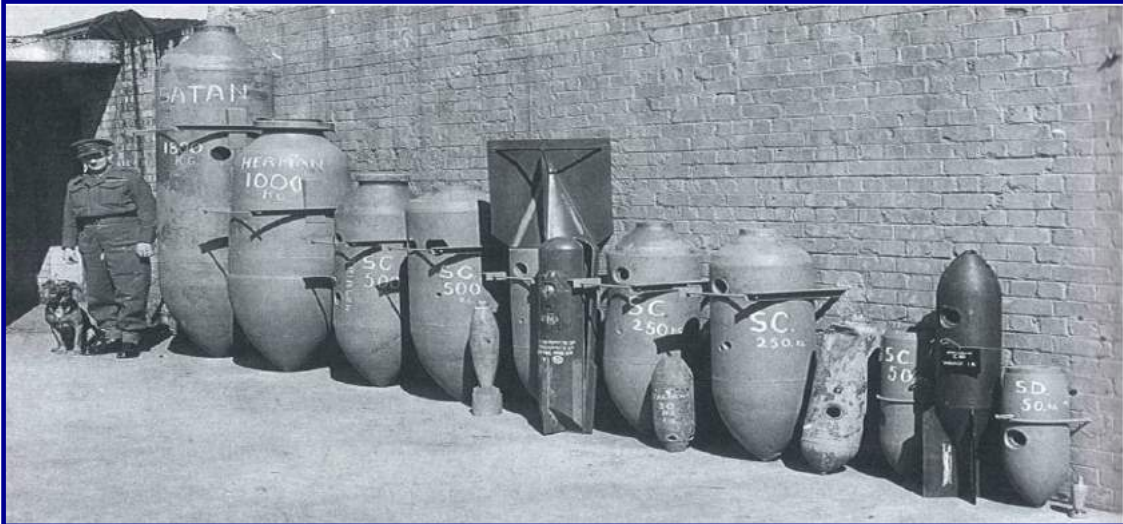
FIGURE 3: Range of HE bombs dropped on the United Kingdom.

NOTE: The smaller sub-munitions (Bomblets) seen to the right, ranged in size between 1 and 3kg, were dropped in large numbers and were intended as incendiary bombs, anti-personnel bombs or as bombs filling both roles. The smaller bomblets were dropped in larger container bombs designed to hold between 360 and 620 of the bomblets. The containers were designed to burst open at a predetermined height above ground level, dispersing the bomblets over a wide area. Air raid damage was far greater by using both incendiary, and HE bombs on a single raid. The fires started by the incendiaries being rapidly spread by the blast waves from the HE bomb. This scenario was shown to devastating effect on the 14th February 1945 in the German city of Dresden. Where fires started and spread by the bombing increased to a point where the oxygen was being sucked into the flames at such a high speed that the fire became a “Fire Storm”. At the time the city's population had increased due to a high number of refugees fleeing the Russian advance to the east, the exact civilian death toll from fire and suffocation will never be known, but is considered to be somewhere between 25,000 and 100,000.

High Explosive (HE) Bomb. Some of the most common type of ordnance to be dropped on the United Kingdom, HE bombs are often the type encountered as UXBs. Relatively thick cased, they are still recovered in remarkably good condition. Ranging in size from 50 to 1700 kg, their typical release height (1,500m) allowed them to penetrate deep into the ground as a result of design or flaw. Towards the end of the bombing campaign, as steel became scarce the German Engineers produced a range of bombs that used steel reinforced concrete as the bomb body. Figure 6.3 shows the range of steel HE bombs dropped on the UK.

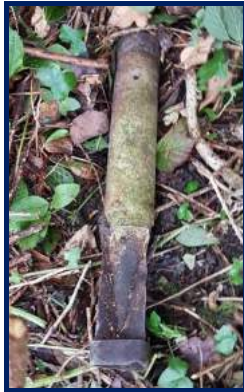
Common German Incendiary Bombs

Left, 1kg incendiary bomblet, and right a 50kg incendiary bomb containing bottles of white phosphorus.

NOTE: Incendiary bomblets were made of a flammable alloy similar in appearance to aluminium, which resists corrosion well. The tail unit was made of thin tin-plate steel and is more prone to have rusted away. Some Incendiary models were fitted with a High Explosive (HE) steel nose. With the tail and explosive nose attached the bomb was 480mm long.

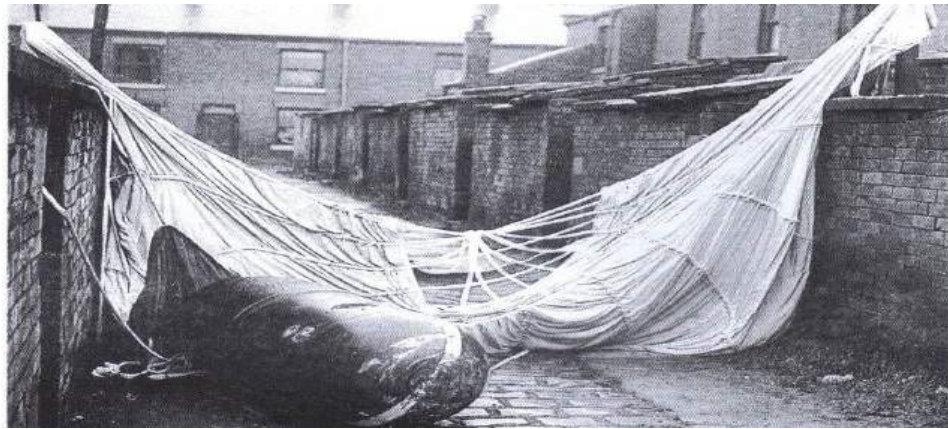
Parachute & Ground Mines

NOTE: all mine fuzes were designed to arm after deployment from the ship, submarine or aircraft, some fuze designs incorporated anti-removal booby traps. Unexploded mines found today are the result of a failure within the arming mechanism or procedure whereby the mine never fully armed. Sudden shock or jarring of a weapon in this state has the potential to complete the arming sequence and could result in the mine detonating with lethal consequences.
