Oxfordshire Railfreight Ltd  
Oxfordshire RFI  
Ardley, Oxon

Phase 2 Geo-Environmental Assessment

<b>Document Number:</b>	OFRI-BWB-ZZ-XX-RP-YE-0001-Ph2_P1
<b>BWB Reference:</b>	NTH2479

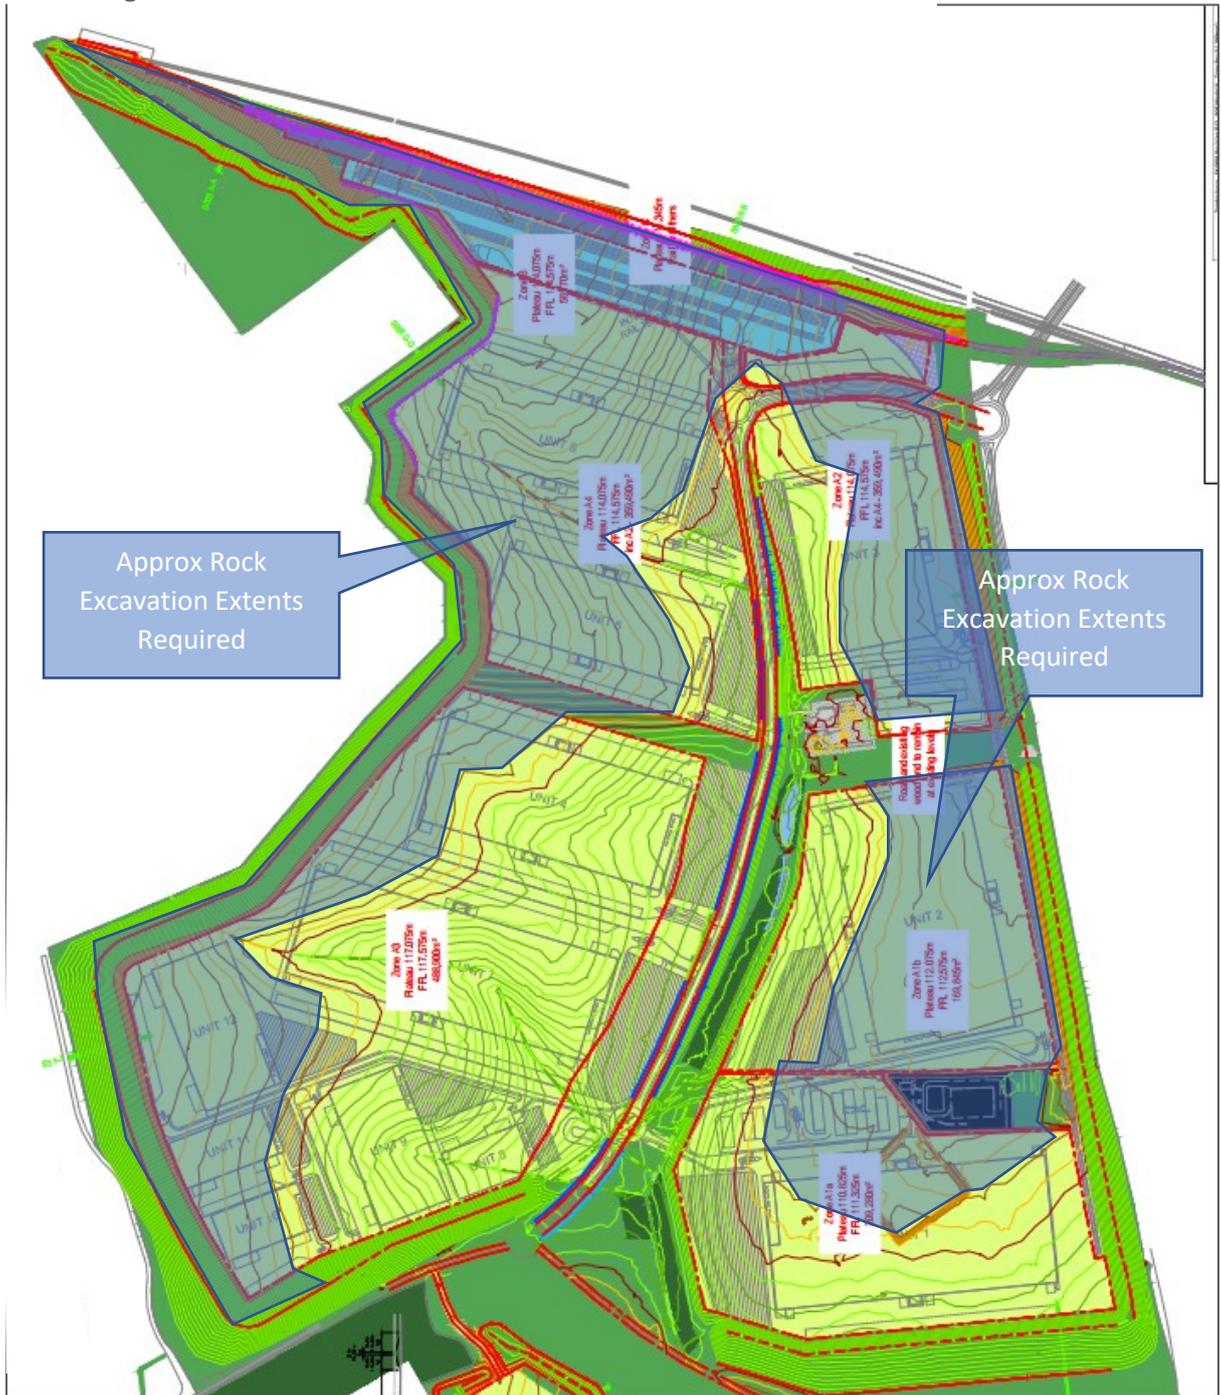
**Figure 7:1: Inferred Rock Excavation Extents**

- 7.4 A large earthworks operation will be required at the site to create level development plateaus. The current earthworks strategy is presented as **Drawing 2** which indicates in excess of 7.0m of cut is required in parts of the site. Most units are located on plateaus? with a portion of cut and fill required on each plot. Currently, only Units 10, 11 and 12 are placed wholly on cut.
- 7.5 Given the shallow bedrock, breaking out competent rock will create a significant constraint at the site. The rock will need to be removed by ripping and/or blasting (drill and blast). An indication of the potential extents of rock excavation is presented on **Figure 7:1** overleaf.

7.22 Extensive rock excavation will be required to facilitate proposed site levels. This is likely to require ripping and also potentially blasting of deeper rock strata. The rock excavated should then be processed by crushing and screening to create the desired rock type which could include general fill, road subbase material and/or drainage medium particularly where retaining structures may be required. Blasting will be subject to constraints relating to nuisance and potential to damage structures, the water reservoir on site being one structure that may be particularly affected.

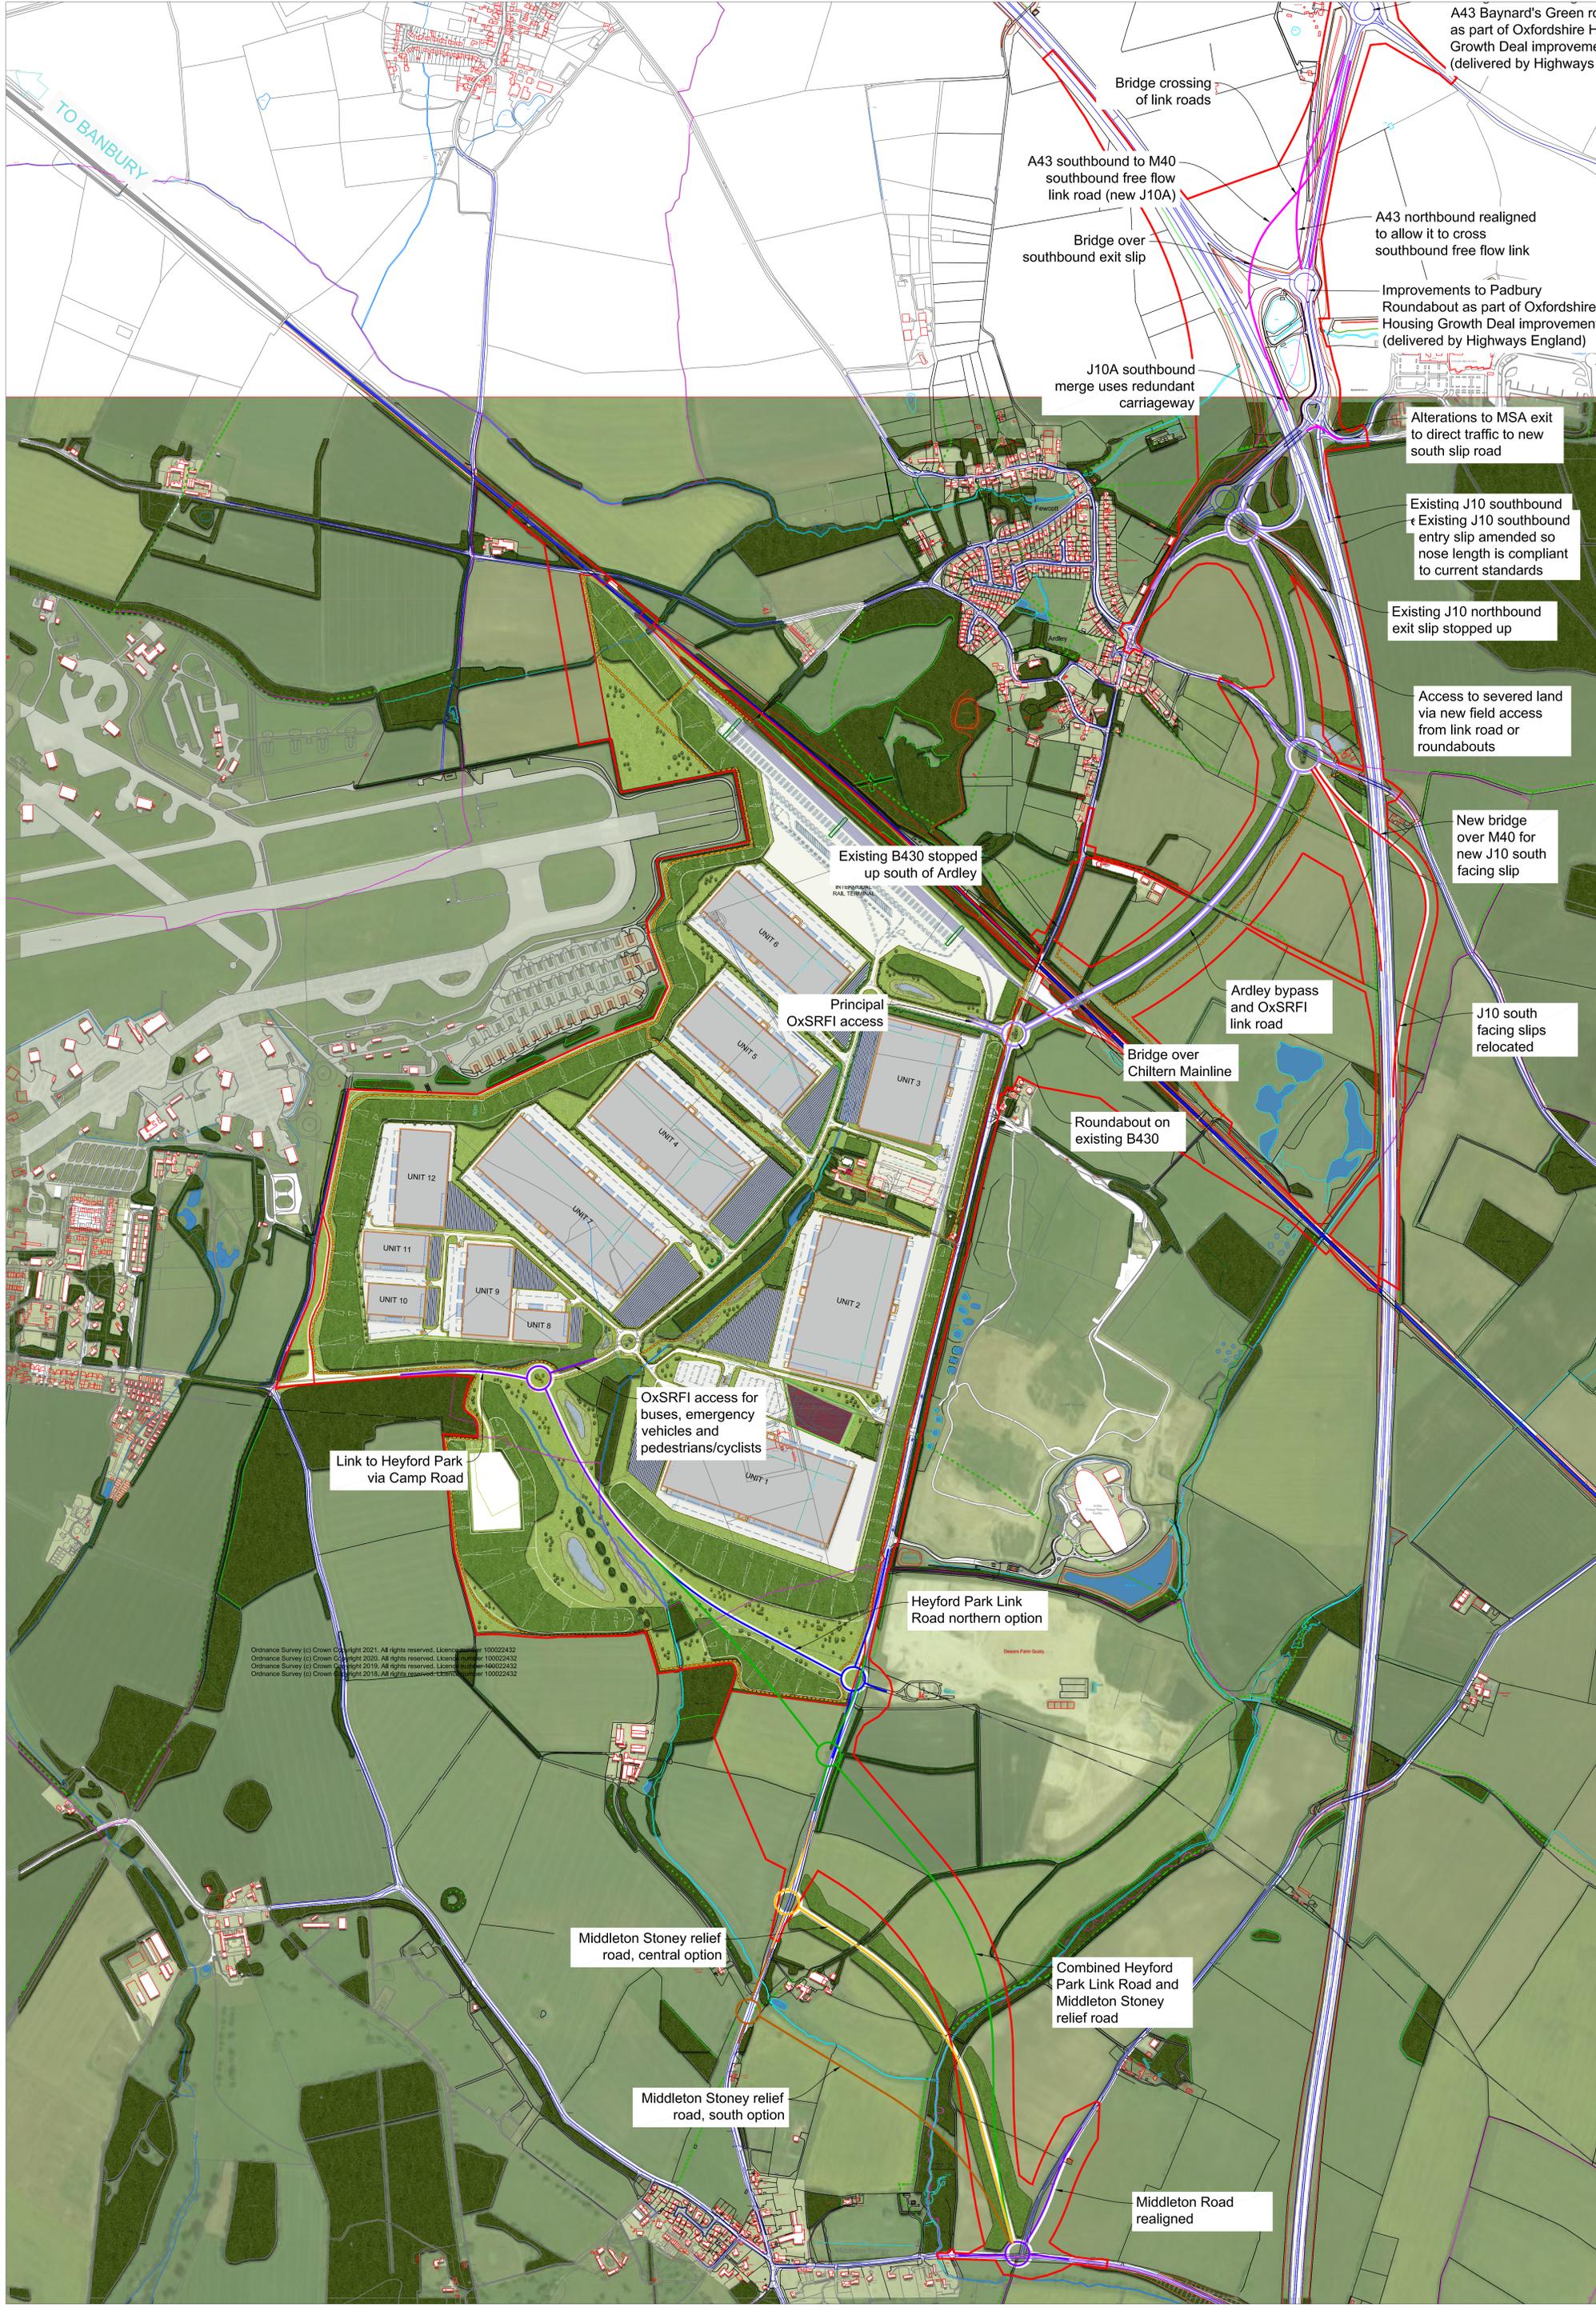
**Drawing 1: Masterplan**

A43 Baynard's Green ro  
as part of Oxfordshire H  
Growth Deal improve  
(delivered by Highways I

Bridge crossing  
of link roads

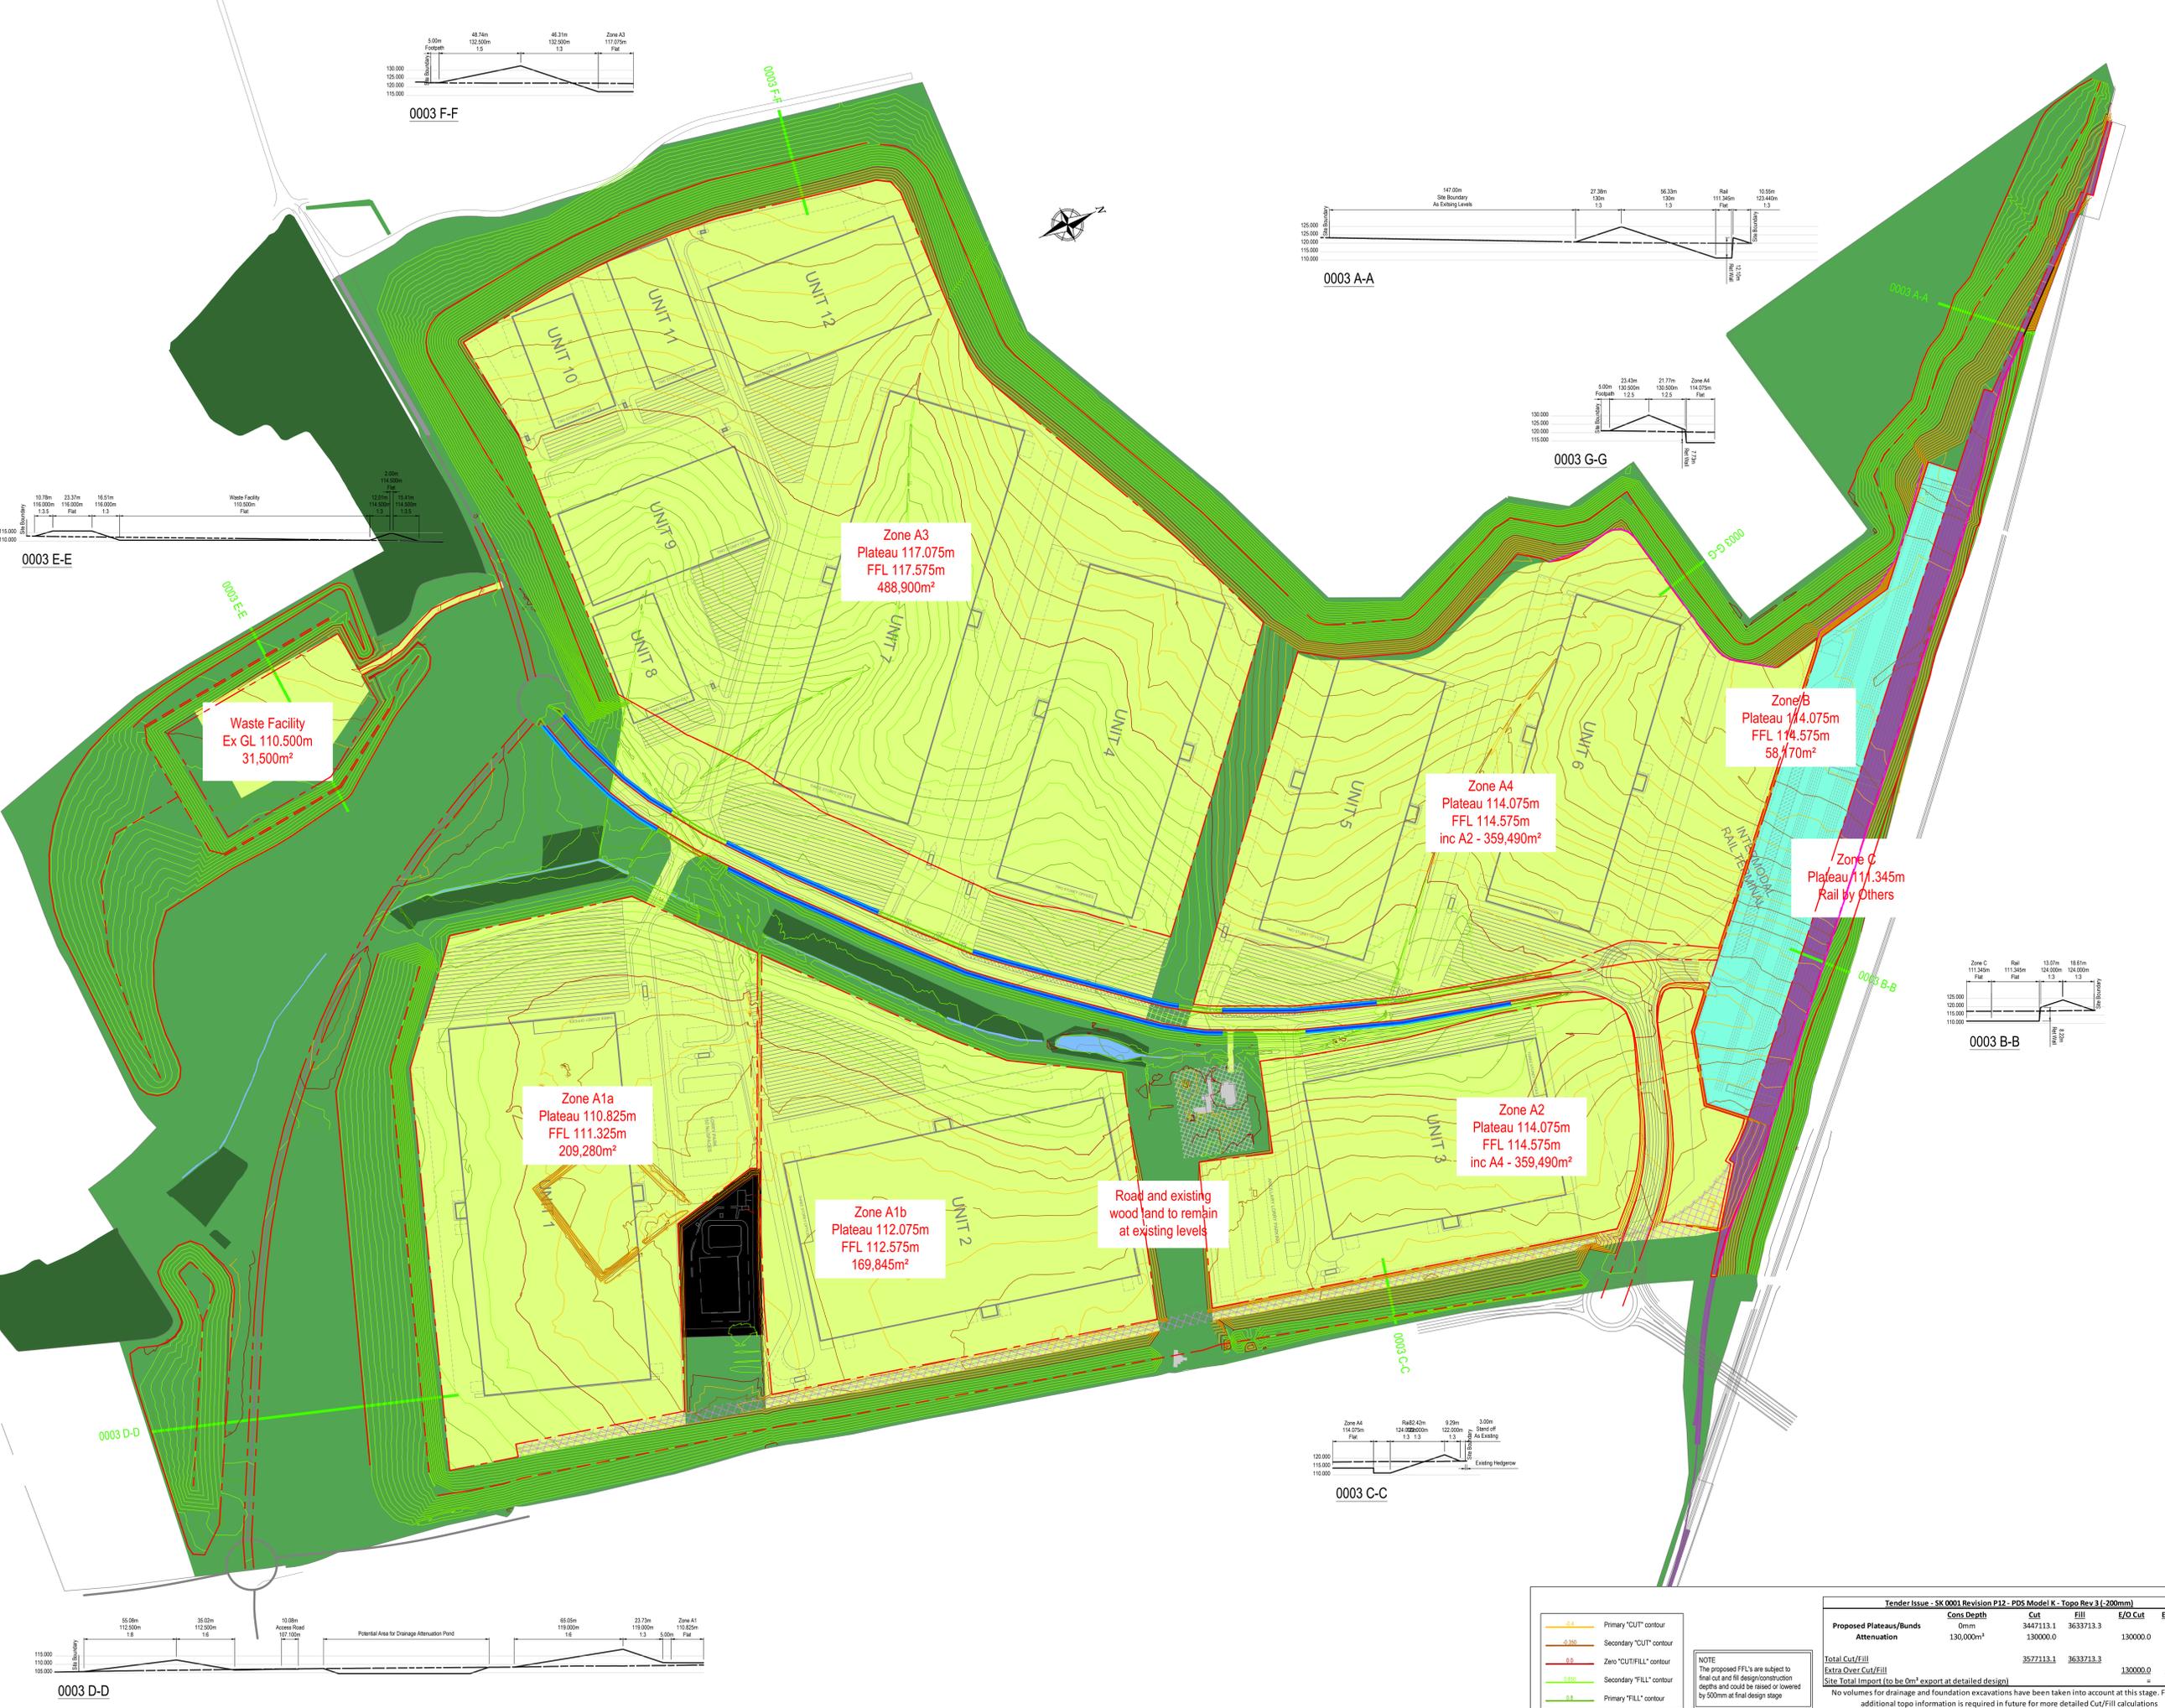
Zone A3  
 Plateau 117.075m  
 FFL 117.575m  
 488,900m<sup>2</sup>

Zone A4  
 Plateau 114.075m  
 FFL 114.575m  
 inc A2 - 359,490m<sup>2</sup>

7.20 As previously discussed, a large earthworks exercise will be required to facilitate the proposed development with the earthworks strategy presented as **Drawing 2**. To manage the earthworks placement an earthworks specification will be required, and it is recommended that this is specified, supervised and validated by a suitably qualified Geotechnical Engineer.
