Oxfordshire Railfreight Interchange Ltd
Oxfordshire RFI
Ardley, Oxon
Minerals Assessment

December 2021

Document Number:	OFRI-BWB-00-XX-RP-YE-0002_MS
BWB Reference:	NTH2479

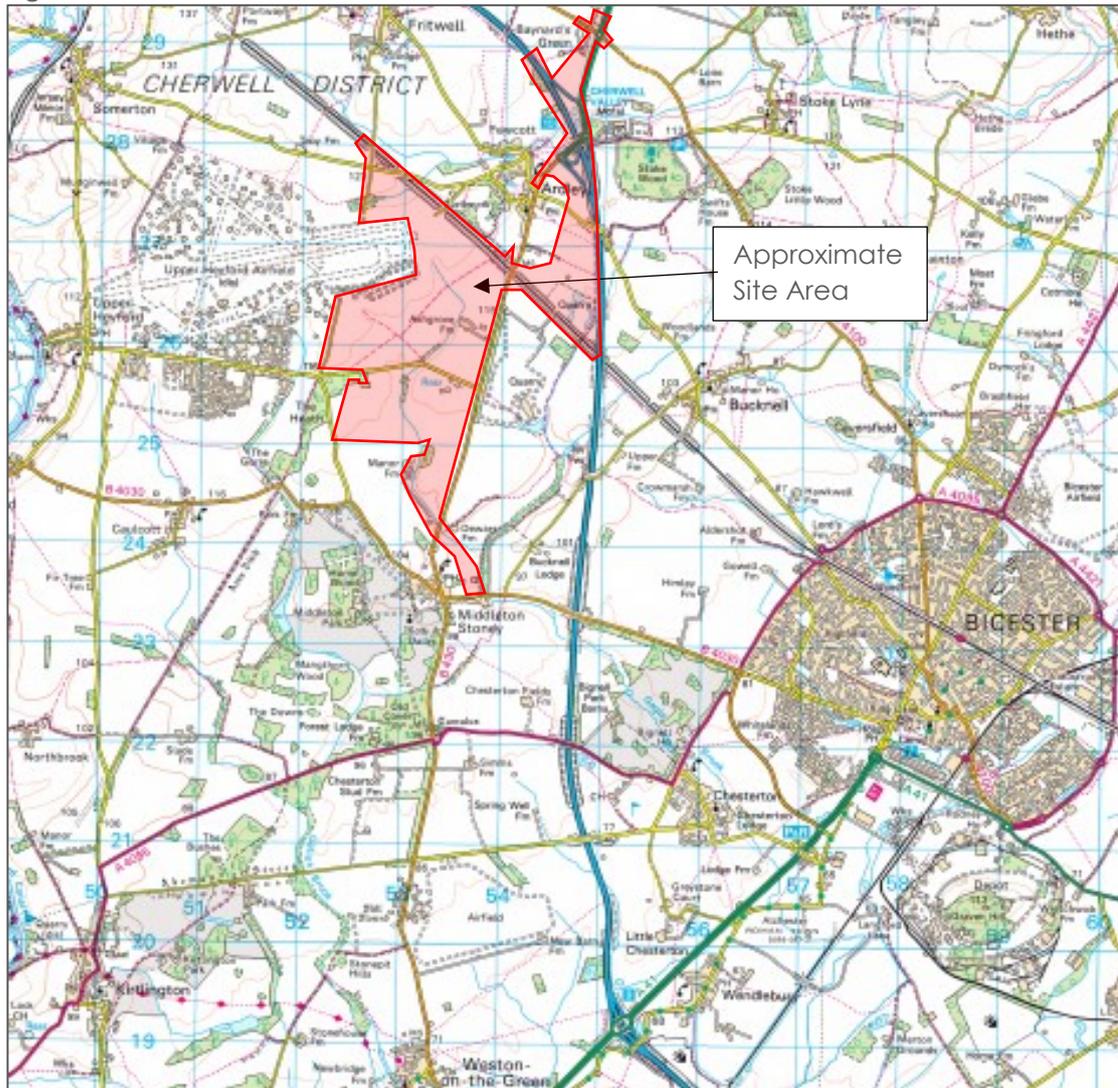
Figure 2:1: Site Location Plan

- 2.1 The site is located immediately south of the village of Ardley, Oxfordshire, centred at National Grid reference 453728, 225258. The approximate location of the site is shown below in **Figure 2:1**.

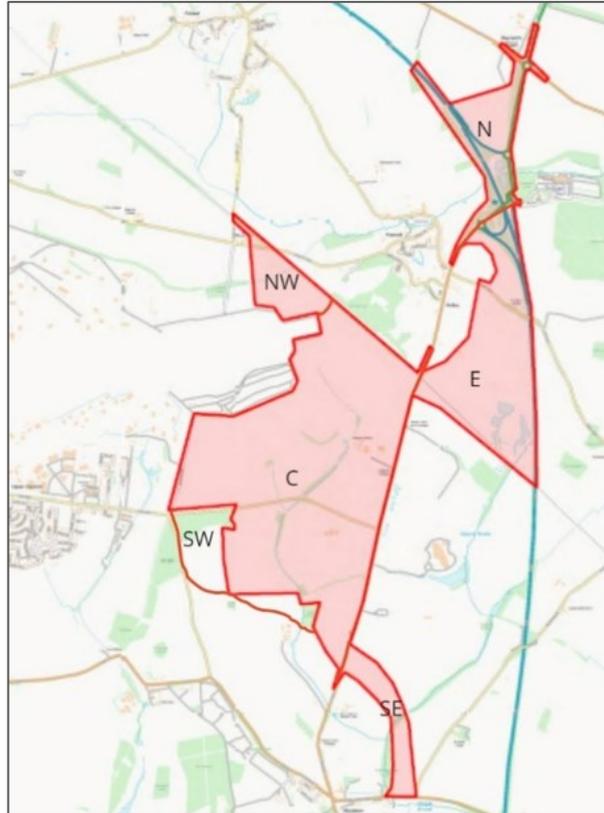
Figure 2:2: Site Areas

- 2.3 The site was visited by BWB personnel on the 09/09/2021 when it was possible to interview the Ashgrove Farm landlord. Site areas described below are outlined on **Figure 2.2** and described in **Section 2.4** to **2.9**.

- 2.4 The area to the north includes an agricultural field between the M40, the A43 and B4100, most of the area is generally flat and at approximately 120m above Ordnance Datum (AOD). The field is divided in two by the junction slip road, with an isolated land with two balancing ponds to the south of it. The slip roads associated with Junction 10 of the M40 are on embankments, and they lead to the A43 to the northeast through a roundabout, and southwest towards Ardley through Padbury roundabout. The junction lies within the valley of Stoke Lyne Brook that runs east to west through it, sloping down from approximately 120m to 110m AOD. A portion of the valley and its watercourse is included within the site to the west of the M40 and to the north of Ardley. A free flow link construction is anticipated on this area.

- 2.5 South of the junction the site includes agricultural fields between the B340, the M40 (here low cutting then at grade) and the Chiltern Main Line rail (in cutting) with exclusion to a quarry area to the southeast. The area is cut in two fields by Ardley Road and generally slopes to the southeast and includes farm buildings close to the B340. Small portions of

- 2.6 The largest site surface is located within open agricultural field including Ashgrove Farm, bounded by the Chiltern Main Line rail to the northeast, the B340 the east, Chilgrove Drive and the former Upper Heyford airbase to the west and northwest, and extending further south Camp Road towards parcels of land belonging to Manor Farm. The area generally gently slopes from 115m to 105m AOD from north to south, and it includes an unnamed watercourse tributary of the Gauge Brook which flows north to south. The field parcels are separated by hedgerows and strips of land with dense tree vegetation are present in the vicinity of the watercourse. Ashgrove Farm cottages and buildings are present within the field, and an infilled pond surface has been identified through consultation with the landlord. To the south of Camp Road, two adjacent fenced areas are present which hosts Ardley Composting Facility and a covered Water Reservoir on earthwork. The ground investigation boundary comprises the full proposed development area with the remaining wider site areas proposed road corridors.

- 2.7 A railway cutting and agricultural fields are located in the northwest of the site, north of Upper Heyford airbase, which is outside of the ground investigation area but was included within the Hydrock (2021) desk study report boundary.

- 2.8 An additional parcel of agricultural land is located to the south of Camp Road and to the north of Manor Farm, which is outside of the ground investigation area but was included within the Hydrock (2021) desk study report boundary.

- 2.9 The village of Middleton Stoney lies several kilometres to the south of the site. A strip of land running to the east of the B340 with a northwest to southeast direction terminating into the B4030 Road, is included within the masterplan for the development of Middleton Stoney Relief Road. The area itself consists of a mixture of predominately arable and pasture fields with Gagle Brook flowing from the northeast to the south. Its topography is generally flat but slopes gently towards the watercourse towards the south of the site. In addition, dense vegetation in the vicinity of the watercourse.

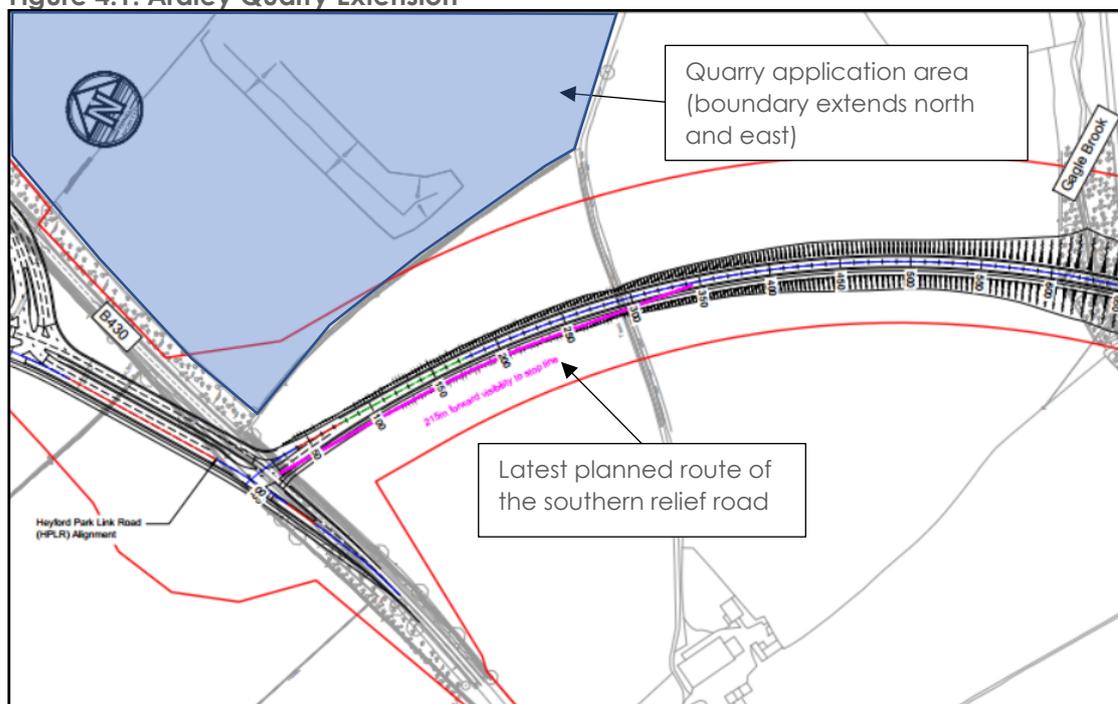
Figure 4:1: Ardley Quarry Extension

- 4.7 **Figure 4:1** below depicts the quarry extension area in relation to the latest proposed road improvement schemes, in particular the Middleton Stoney Relief Road to the south of the site. The proposed road does not impact upon the currently planned extraction of limestone from the southern tip of the Ardley quarry.

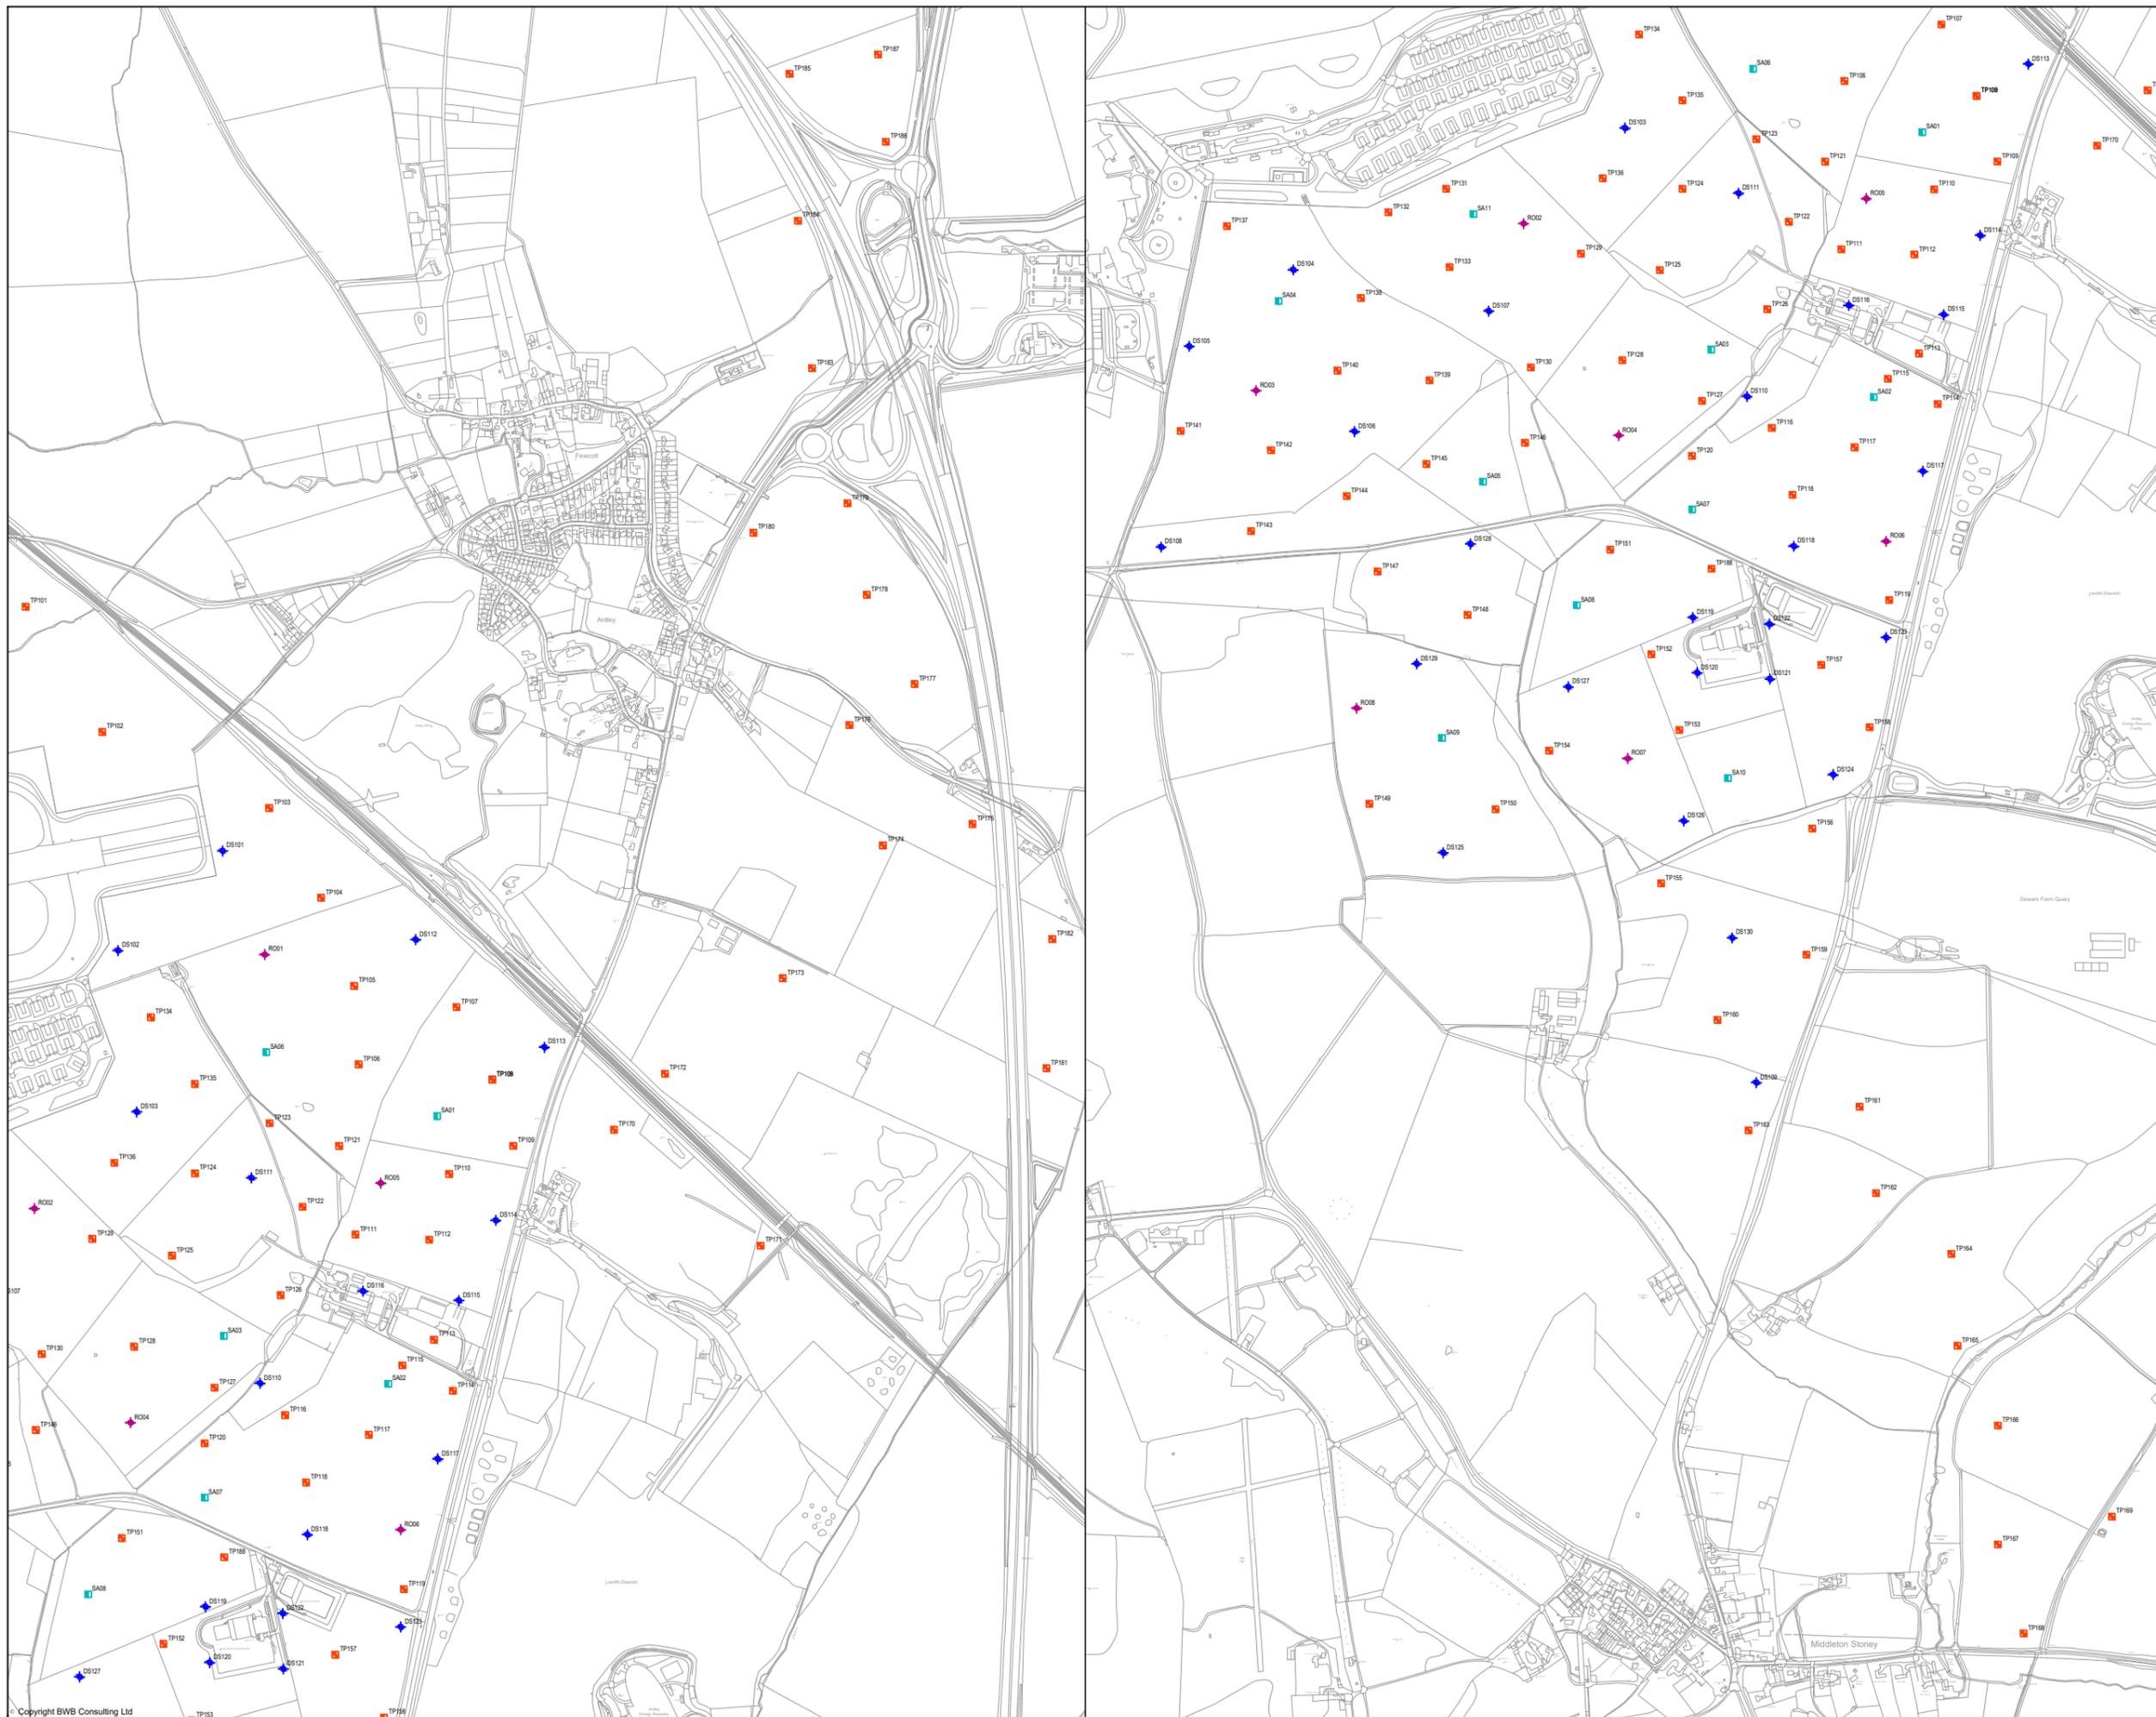
Drawing 2: Exploratory Hole Location Plan

- Legend**
- TP** Proposed Trial Pit Location - Target Depth of ~3.5m bgl
 - SA*** Proposed Trial Pit Location - Target Depth of ~3.5m bgl
 - DS*** Proposed Dynamic Sample Borehole - Typical Target Depth of 5.0m bgl
 - RO** Proposed Rotary Open Hole - Typical Target Depth of ~10.0m bgl

- 3.12 An exploratory hole location plan is presented as **Drawing 2** and exploratory hole logs are presented as **Appendix 2**.
- 3.13 The underlying ground conditions have been classified by the Environment Agency (EA) as follows:

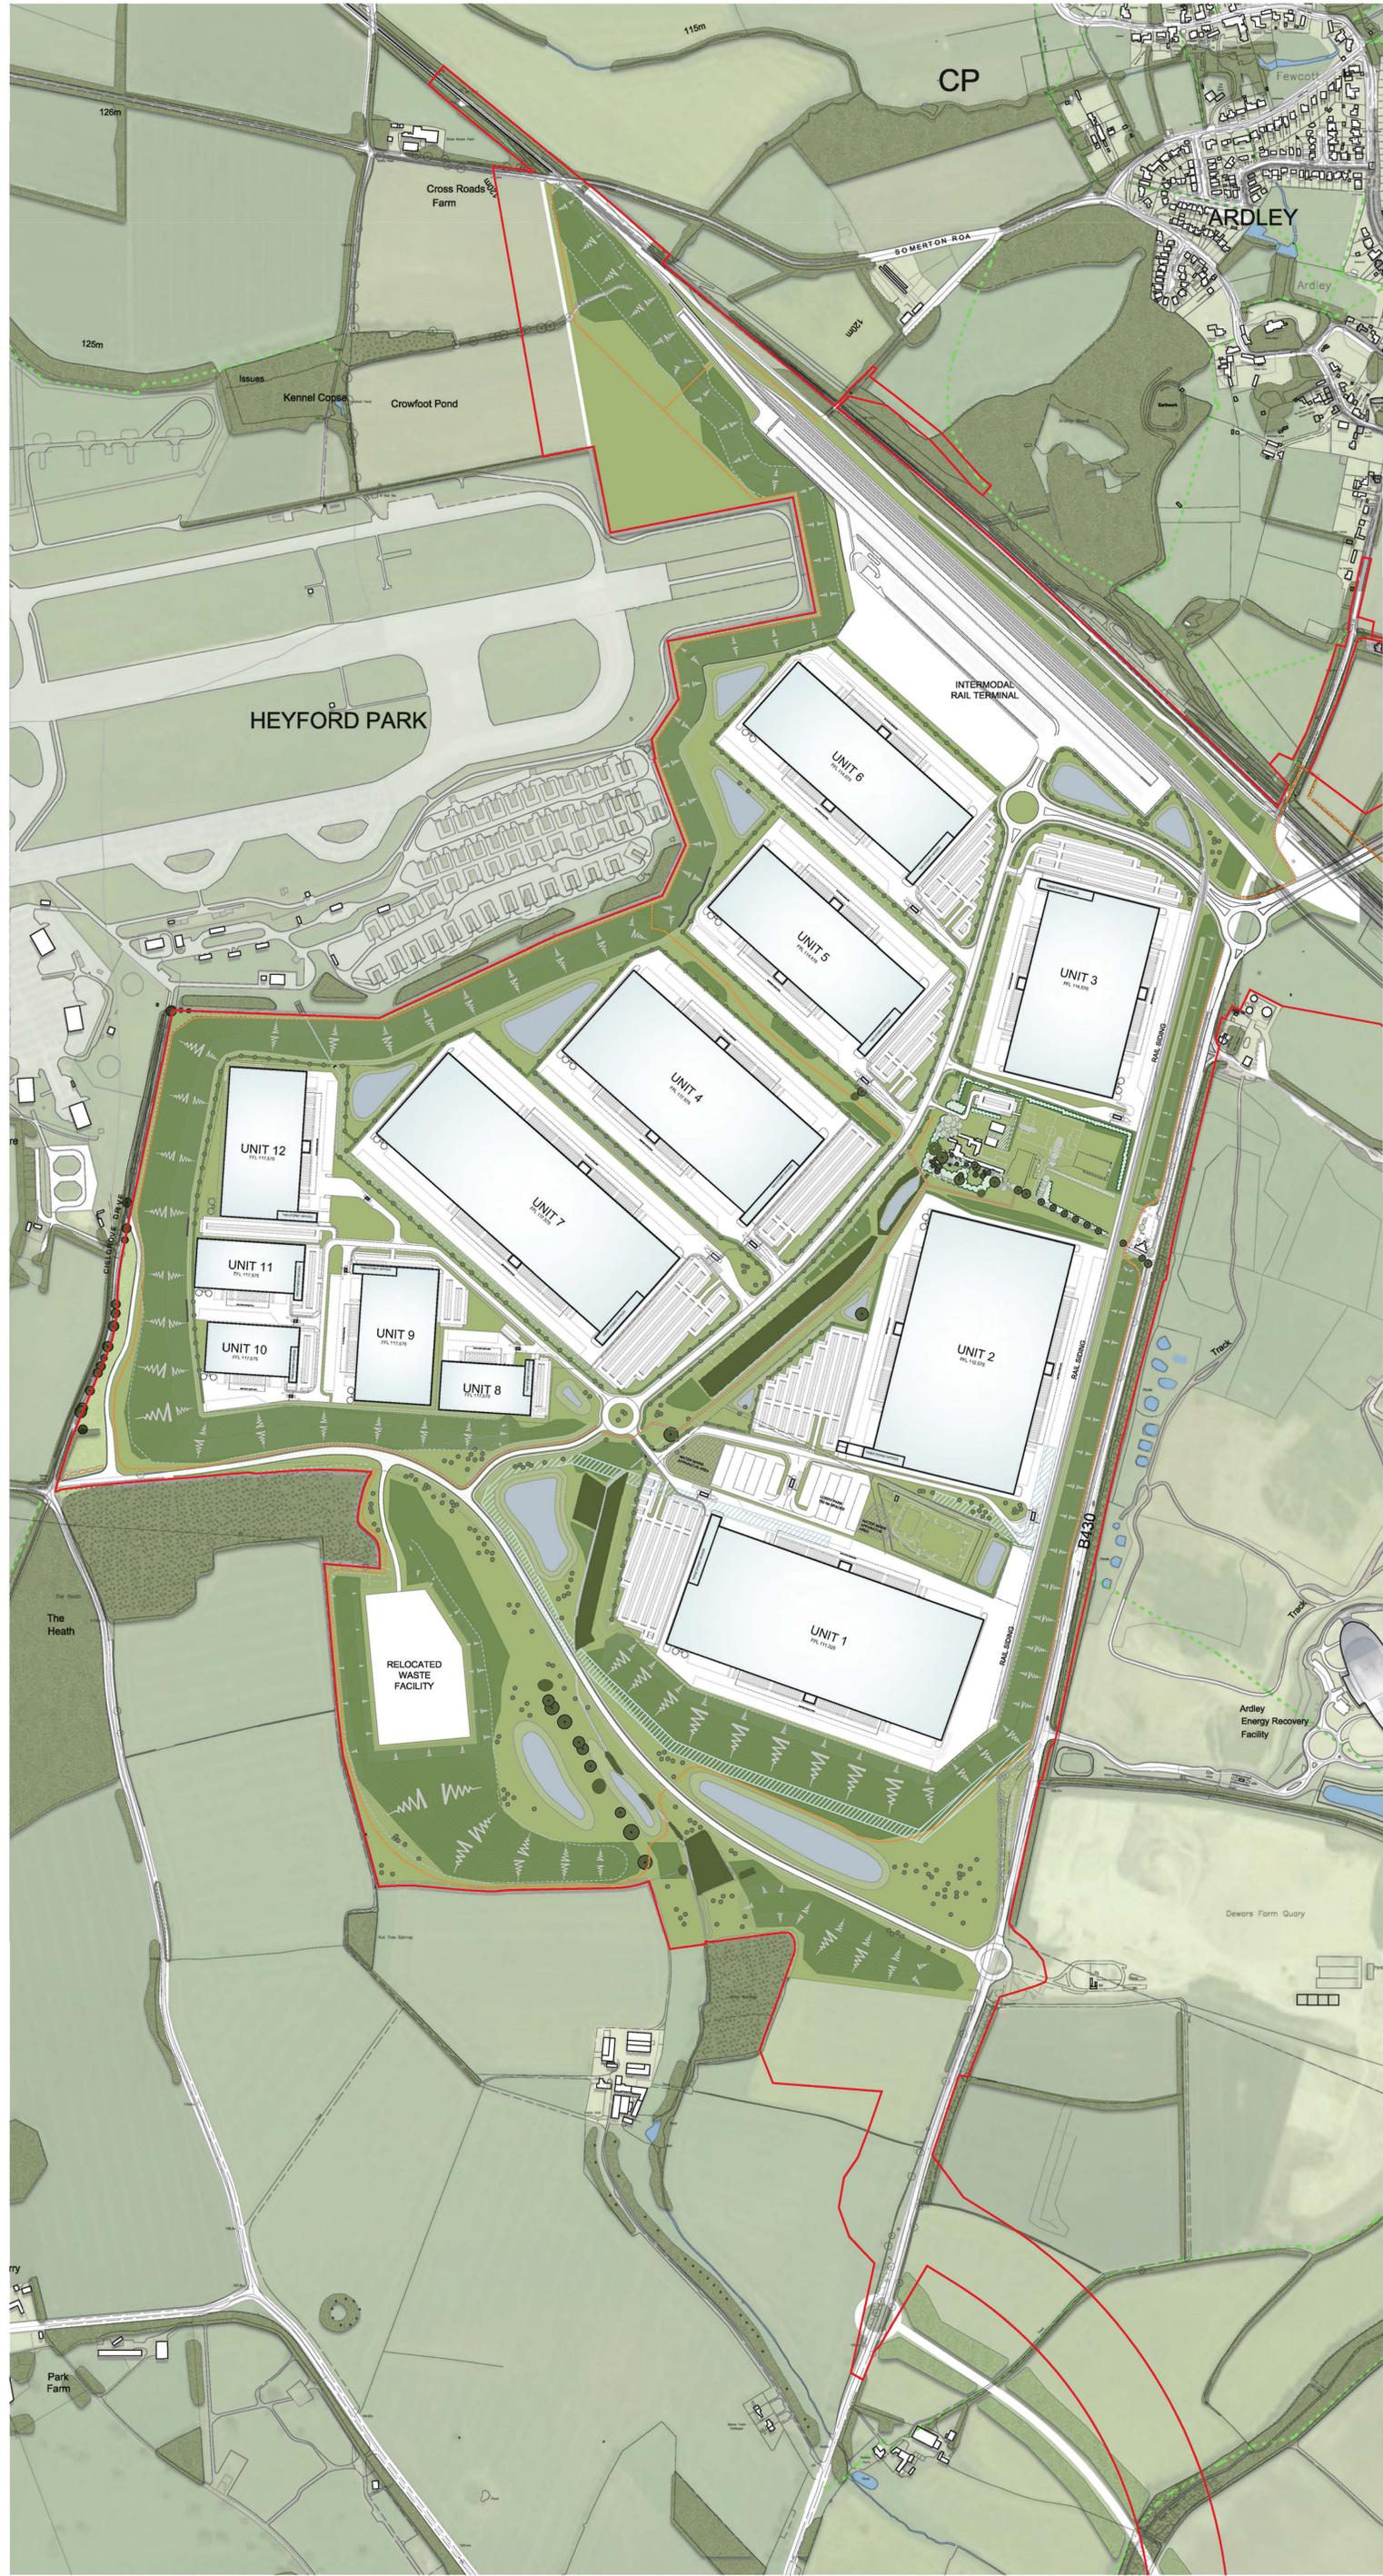
Appendix 1: Proposed Site Layout

PROPOSED LEVELS
 BASED ON CDP LTD'S: PRELIMINARY EARTHWORKS.
 REF: 19-7709-SK 0001.REV P12.
 DATED: MARCH 2020.
 NOTE: FINISHED FLOOR LEVELS SUBJECT TO CHANGE
 THIS DOCUMENT REQUIRES UPDATING.

INTERMODAL RAIL TERMINAL
 BASED ON INTERMODALITY'S: RAIL INFRASTRUCTURE GENERAL ARRANGEMENT.
 REF: IMT J0235_D5.24.
 DATED: 18.08.2021.

- 1.3 An Illustrative Masterplan is set out in **Appendix 1** (ref: 31105-FE-66, dated October 2021) which demonstrates a potential site layout. However, this will not be conditioned as part of the outline application. Further detail on the scheme layout will be submitted at Reserved Matters stage.
